## Building EQ Energy Audit Narrative Report

| Building Name | ASHRAE HQ |

| Energy Auditor (name/company) | Commissioning and Green Building Solution, Inc. | | | |
| Assessment Date | 2013-06-04 | | | |

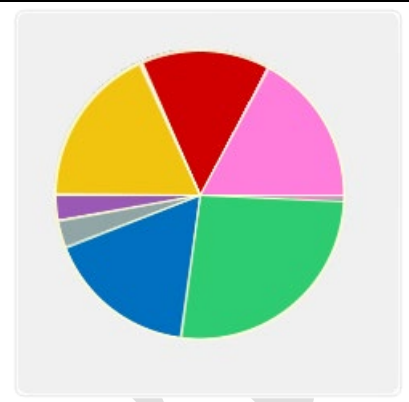
### Energy End Use Breakdown

| End Use | Energy Use | Color |
| Lighting | 266806 | Green |
| Plug Loads | 166313 | Blue |
| Service Water Heating | 30065 | Grey |
| Exterior Lighting | 27360 | Purple |
| Heat Reject | 176814 | Yellow |
| HVAC VRF | 141147 | Red |
| Data Center | 175499 | Pink |
